Wulfsberg Electronics <i>A Chelton Group Company</i>		TITLE: SERVICE BULLETIN WSB IDU-III-17 (IDU LIMITS DIGITAL GAIN MODIFICATION)	
APPROVALS DRAWN Robert DuRall CHECKED Dean Boston PRODUCT MANAGER	DATE 07/22/05 07/22/05	SIZE A	CAGE CODE 1B7G3
ENGINEER Robert DuRall ISSUED Vern Wallace	07/22/05 07/25/05	DWG NO. 150-045036	REV A
Typed signatures indicate approval. Handwritten signature approval of this document is on file at Wulfsberg Electronics, Prescott, Arizona.		SCALE: NONE	DO NOT SCALE DRAWING

SERVICE BULLETIN

EQUIPMENT: IDU-III

BULLETIN NUMBER: WSB IDU-III-17 Revision A

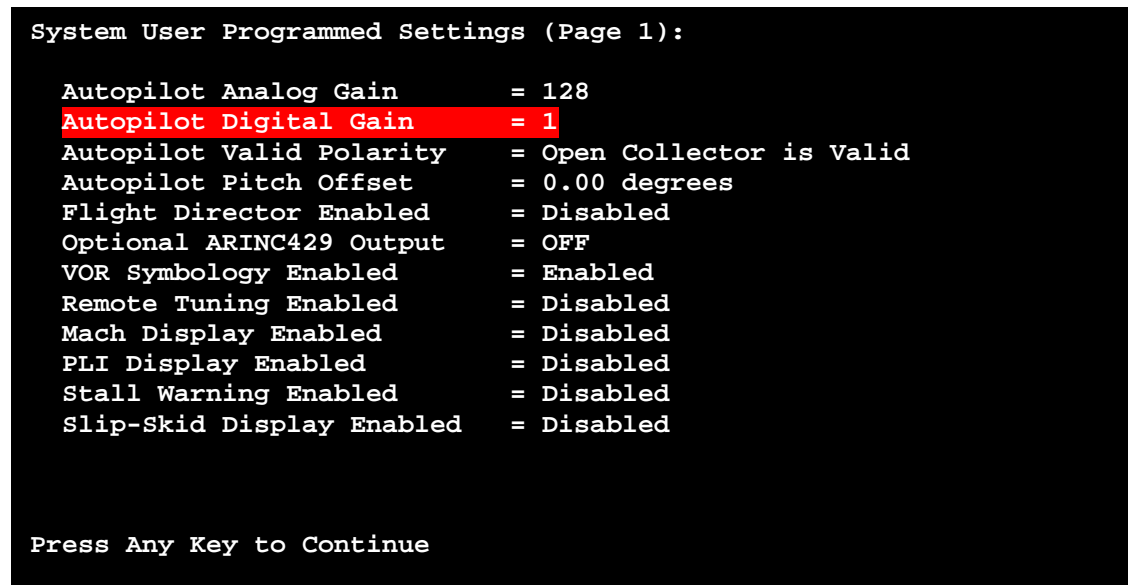
Figure 3 System User Programmed Settings (Page 1)

6. Press any button or rotate the right-hand encoder three (3) times until the “System User Programmed Settings (Page 1)” is displayed.
7. View the *Autopilot Digital Gain* option (As shown in red in Figure 3).

8. If the *Autopilot Digital Gain* option displays a value other than “1”, proceed with the Modification Procedure in this Service Bulletin.
