**SERVICE INFORMATION LETTER 012**

Subject: Shadin ADC-2000 Tray Inspection

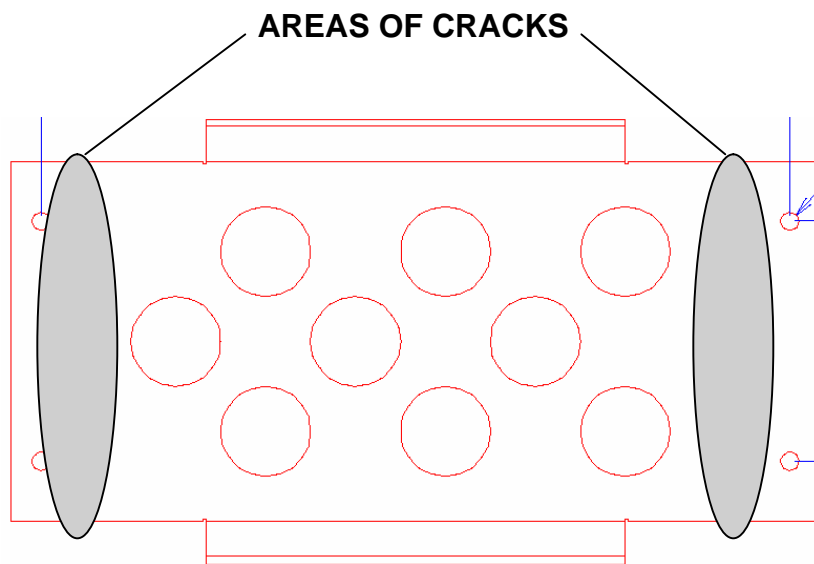
There have been reports from the field of cracking found on the aluminum mounting tray around the bend radius of the tray assembly. Every operator should inspect the mounting tray as soon as possible, then at a minimum of every annual inspection to determine if the tray has developed cracks. If cracks are found, the tray assembly shall be replaced at the earliest convenience.
