Wulfsberg Electronics <i>A Chelton Group Company</i>		TITLE: SERVICE BULLETIN WSB IDU-III-17 (IDU LIMITS DIGITAL GAIN MODIFICATION)	
APPROVALS DRAWN Robert DuRall CHECKED Dean Boston PRODUCT MANAGER	DATE 07/22/05 07/22/05	SIZE A	CAGE CODE 1B7G3
ENGINEER Robert DuRall ISSUED Vern Wallace	07/22/05 07/25/05	DWG NO. 150-045036	REV A
Typed signatures indicate approval. Handwritten signature approval of this document is on file at Wulfsberg Electronics, Prescott, Arizona.		SCALE: NONE	DO NOT SCALE DRAWING

SERVICE BULLETIN

EQUIPMENT: IDU-III

BULLETIN NUMBER: WSB IDU-III-17 Revision A

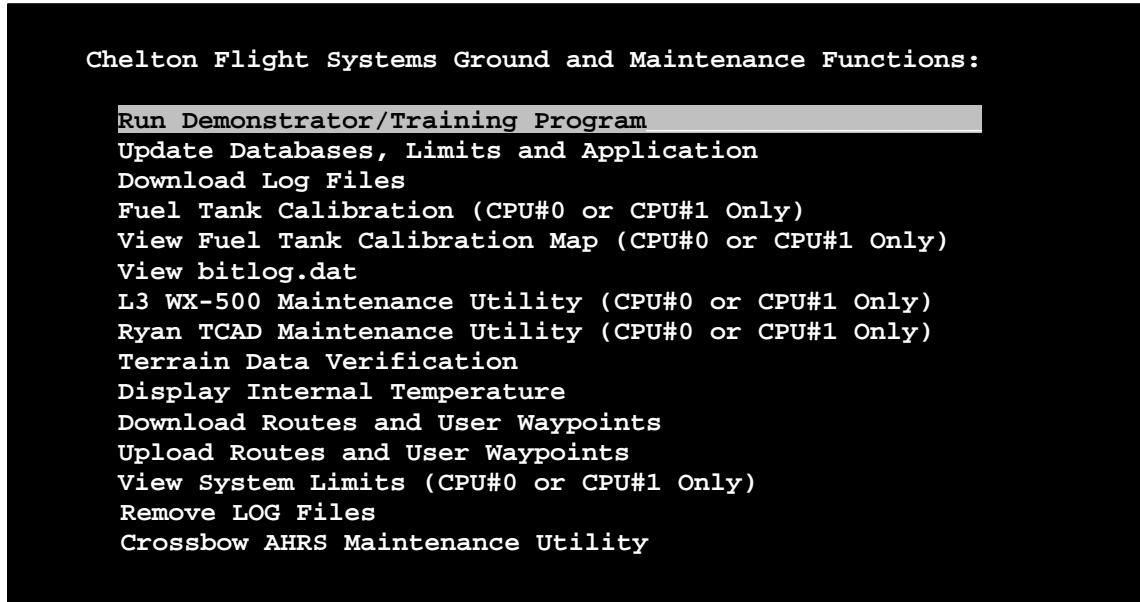
Figure 1 EFIS Ground Maintenance Menu

3. Apply power to the EFIS system.
4. Verify the PFD or single MFD unit displays the Ground Maintenance menu (See Figure 1).

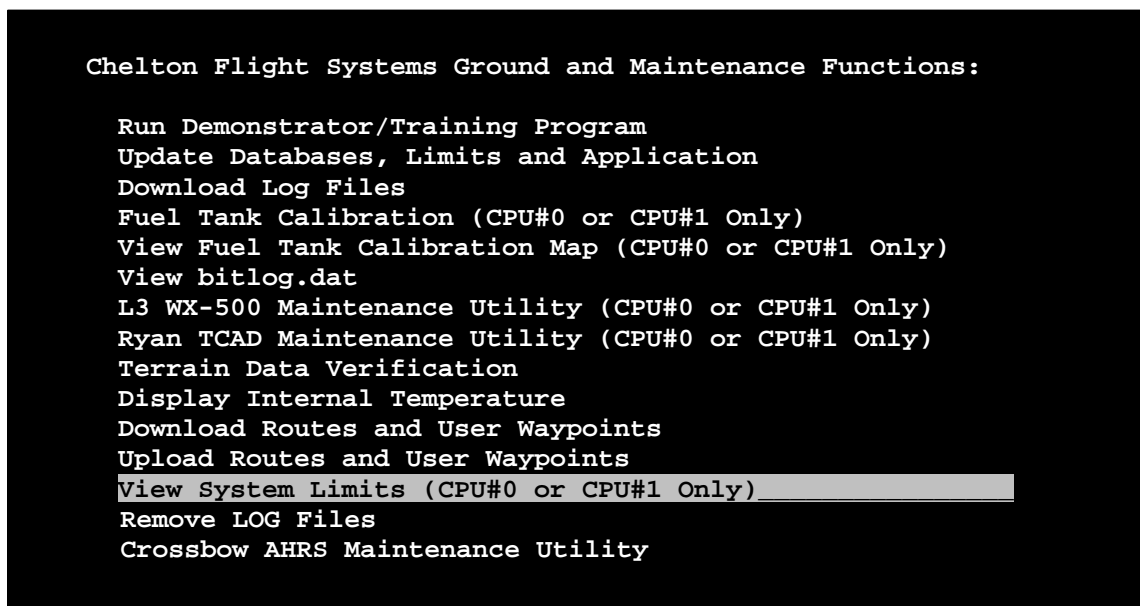
Figure 2 View System Limits

5. Rotate the right-hand encoder until the “View System Limits (CPU#0 or CPU#1 Only)” is highlighted then press in the right-hand encoder (See Figure 2).
